**CWA COMPLIANCE EVALUATION INSPECTION REPORT
U.S. ENVIRONMENTAL PROTECTION AGENCY, REGION 5**

Purpose: Compliance Evaluation Inspection

Facility:
Ex. 6 (Personal Privacy) Winding Acres Farm
Ex. 6 (Personal Privacy)
Ex. 6 (Personal Privacy) Stephenson County
Ex. 6 (Personal Privacy)

Date of Inspection: September 24, 2020

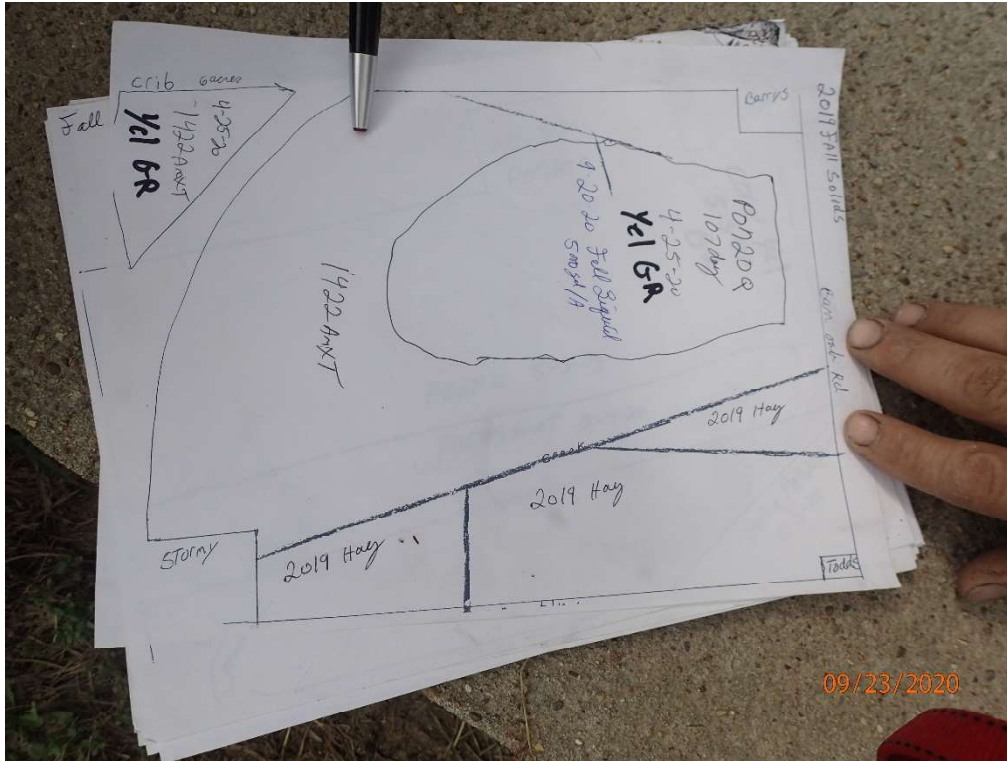
1: P9230001

Description: Example of field map and land application records.

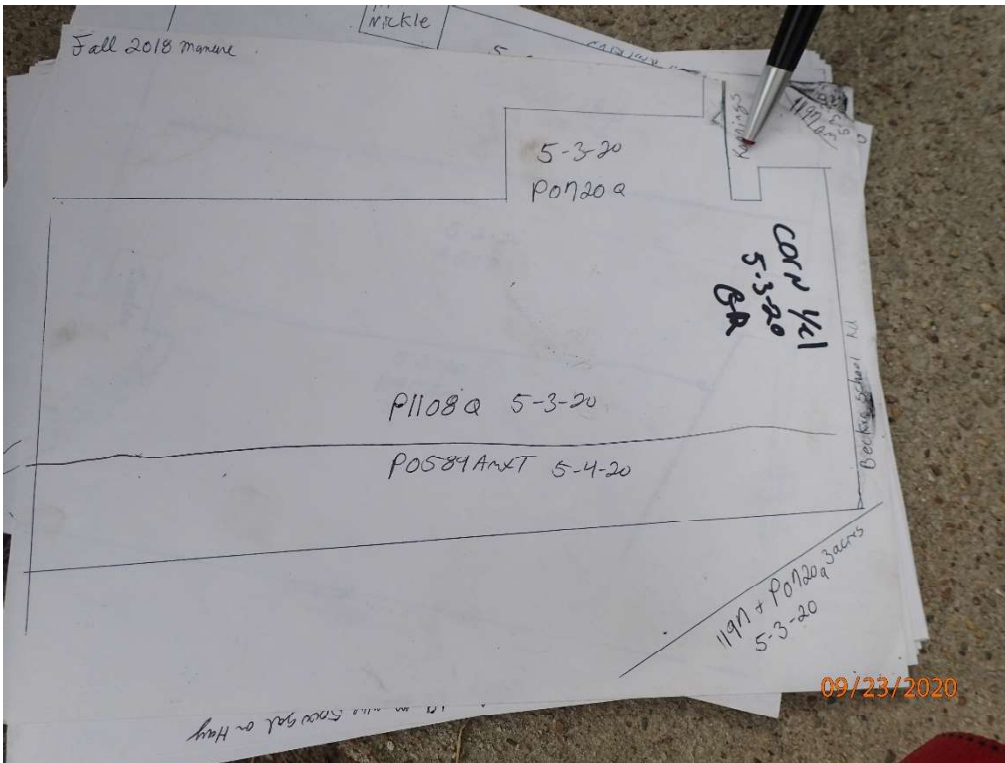
2: P9230002

Description: Example of field map and land application records.

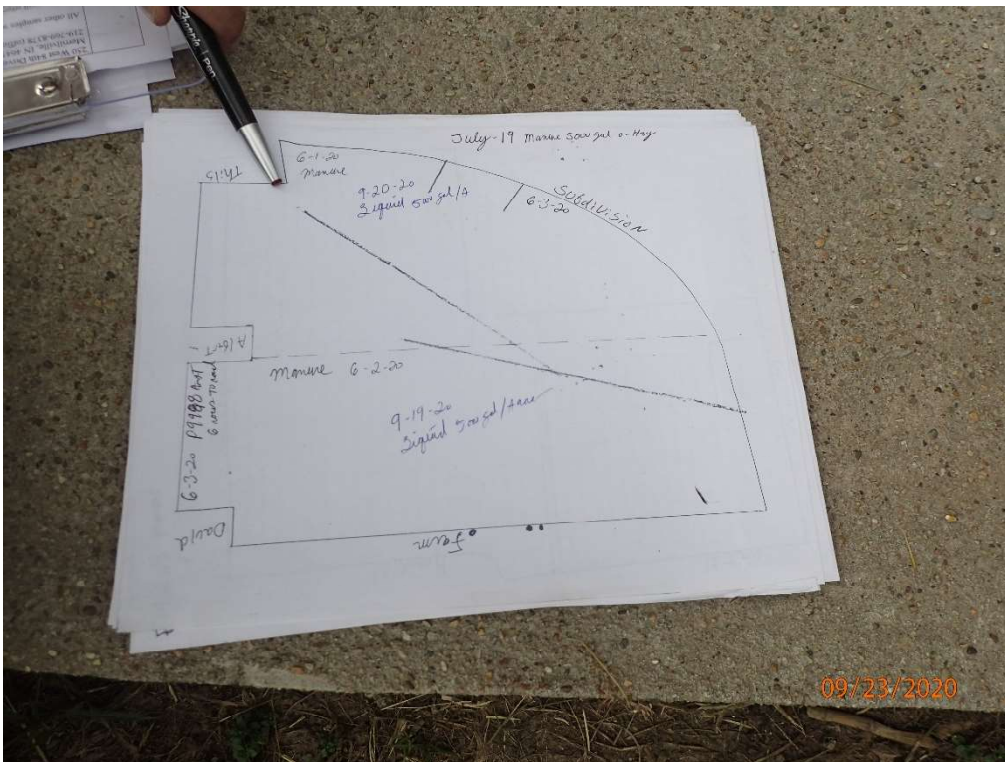
3: P9230003

Description: Example of field map and land application records.

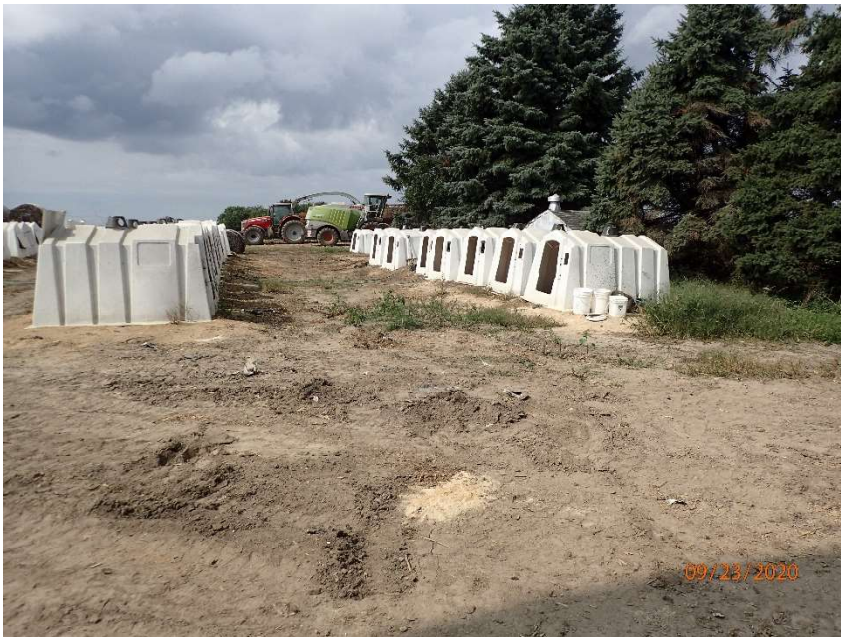
4: P9230004

Description: Outdoor calf hutch area.

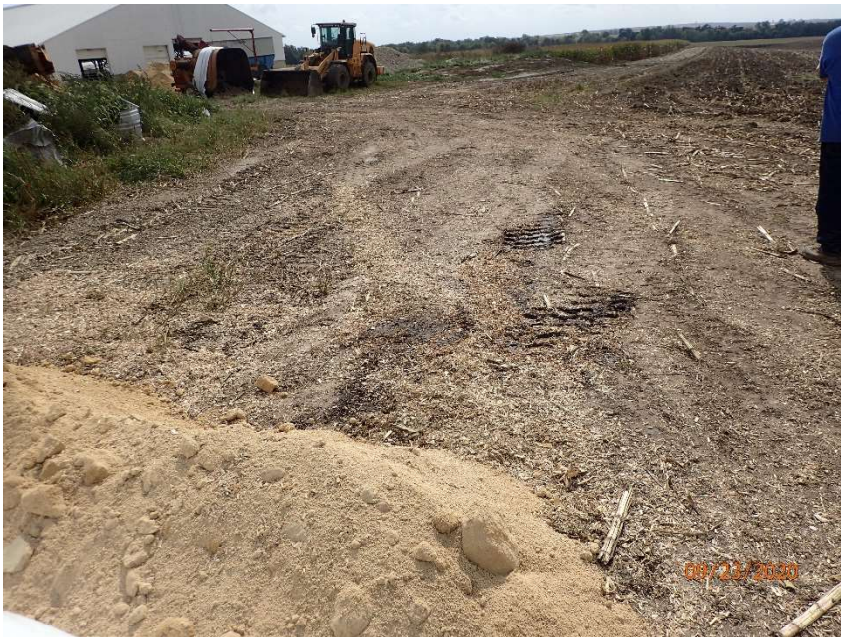
5: P9230005

Description: Sand sealing South end of silage bags on west side of Facility.

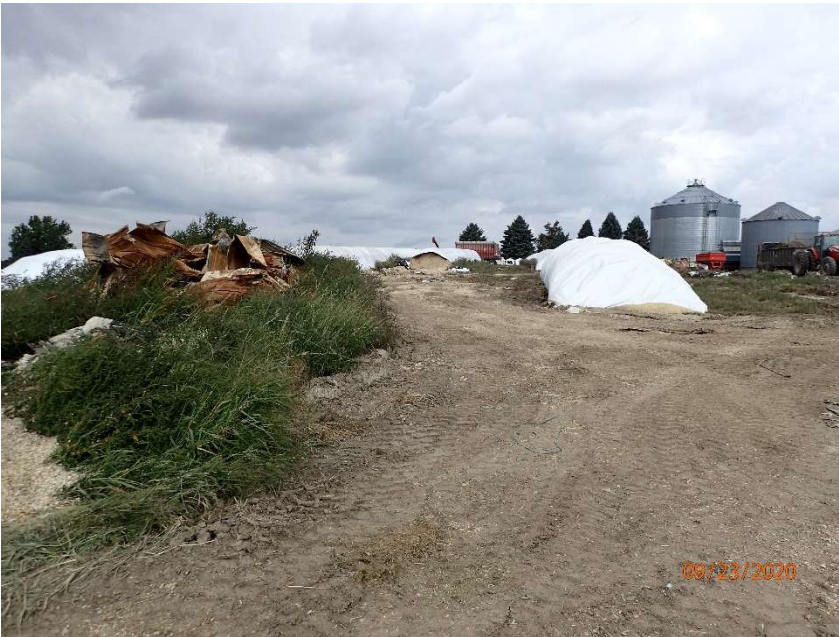
6: P9230006

Description: Looking northeast along silage bags on the west side of the Facility.

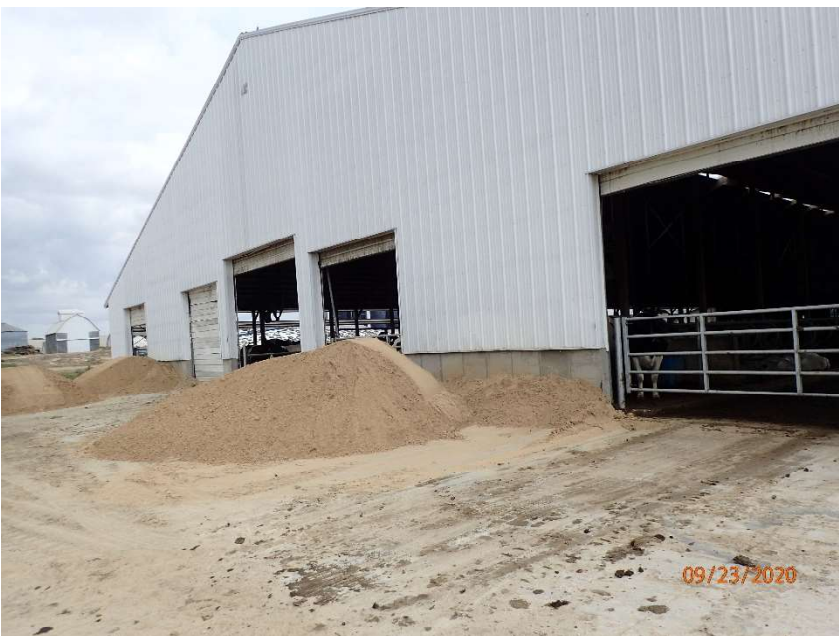
7: P9230007

Description: New sand bedding stacked on the west side of the Big Barn.

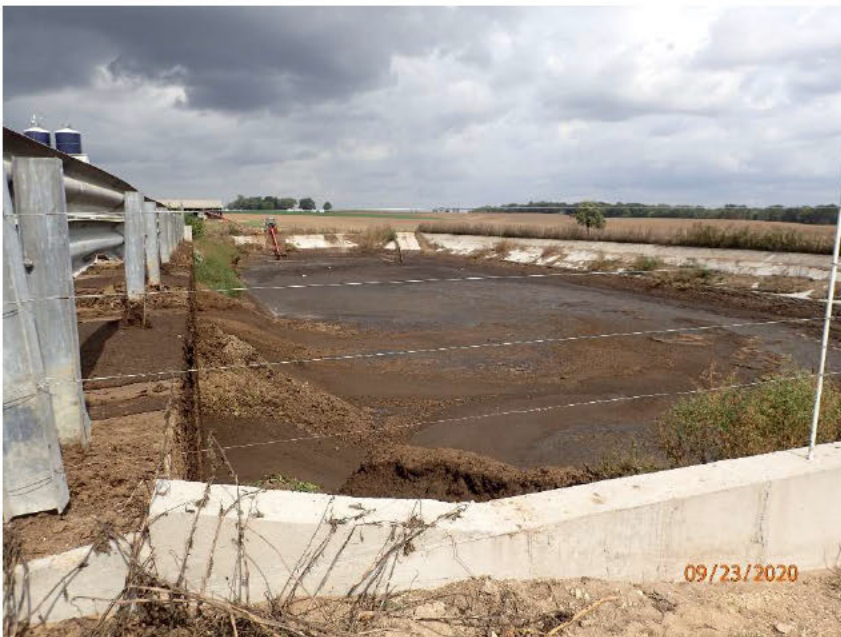
9: P9230009

Description: Looking north from the southwest corner of the Big Pit. Big Barn manure push off to the left.

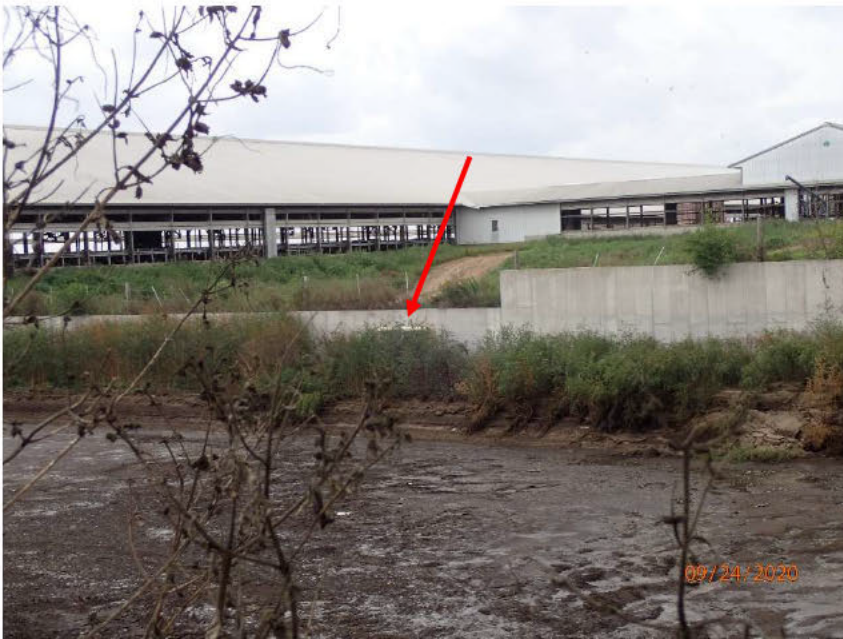
13: P9240013

Description: Big Pit as seen from the east side. Note depth gauge (red arrow).

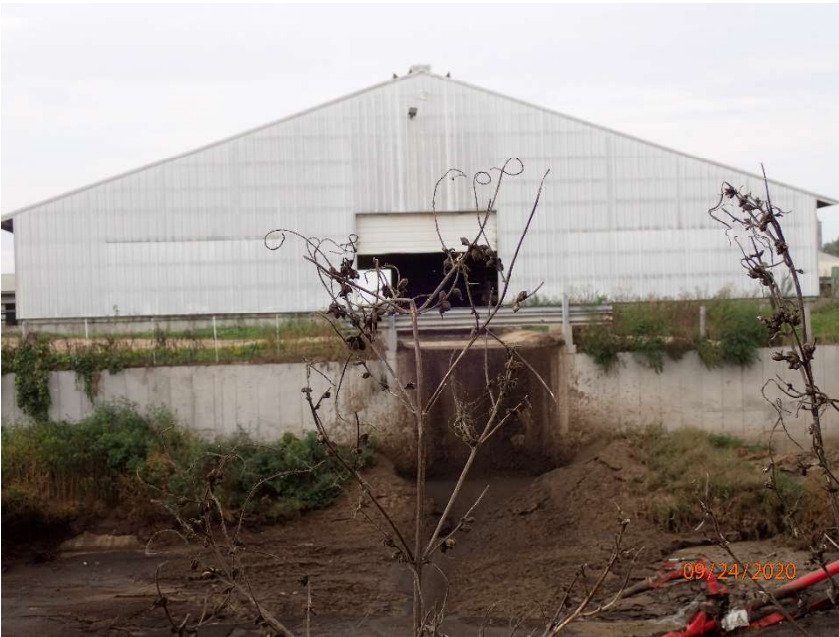
14: P9240014

Description: Manure push off area of the Middle Barn.

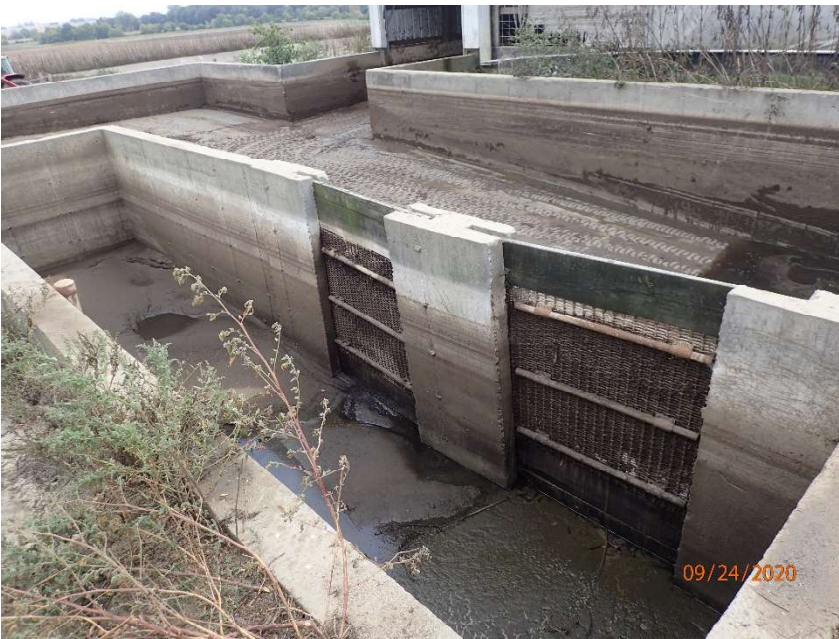
19: P9240019

Description: Little Pit as seen from the northwest corner. Liquids enter this center section through the slatted weep wall.

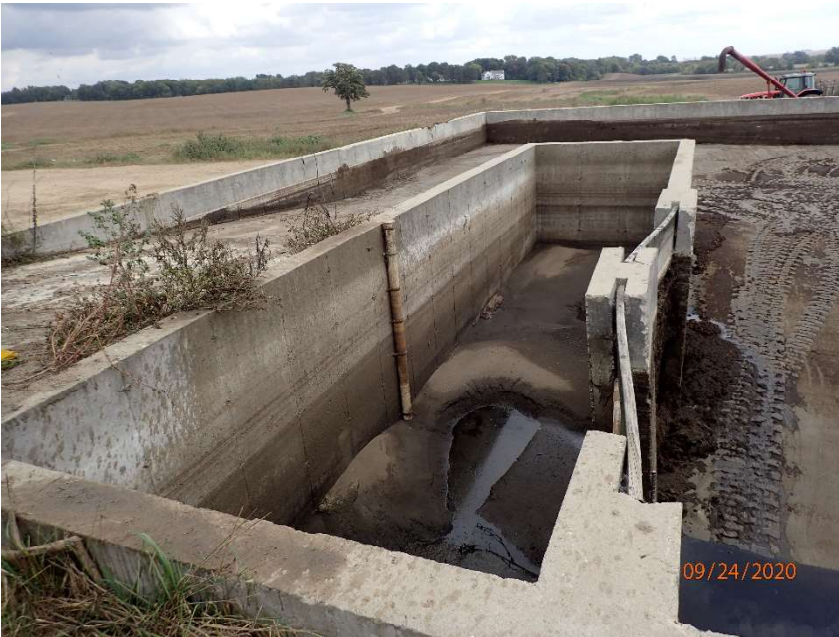
20: P9240020

Description: Little Pit as seen from the west side. Center portion collects liquids from the slatted weep wall.

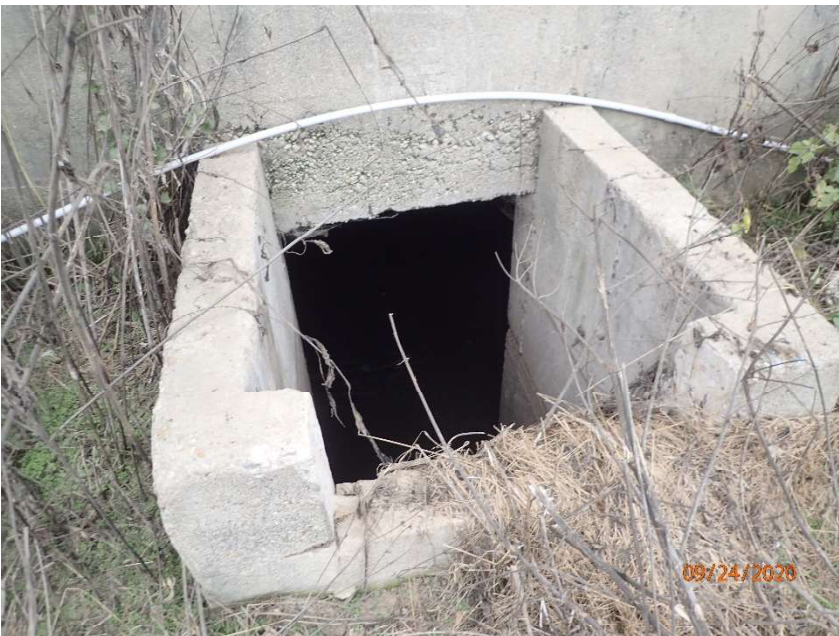
21: P9240021

Description: Pump out location of pit under the Old Dairy Barn.

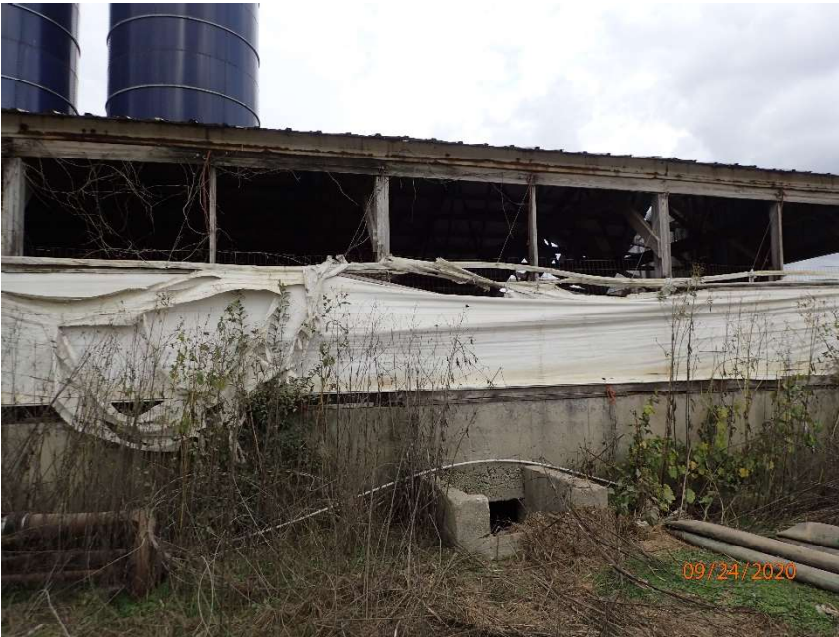
22: P9240022

Description: Pump out location of pit under the Old Dairy Barn.

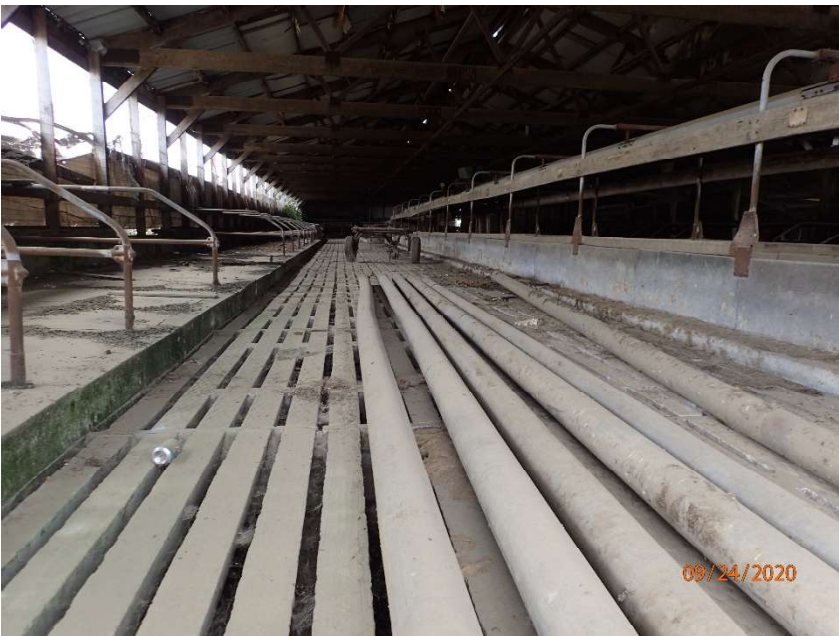
23: P9240023

Description: Interior of the Old Dairy Barn as seen from the east end. Note slatted floor above under barn pit.

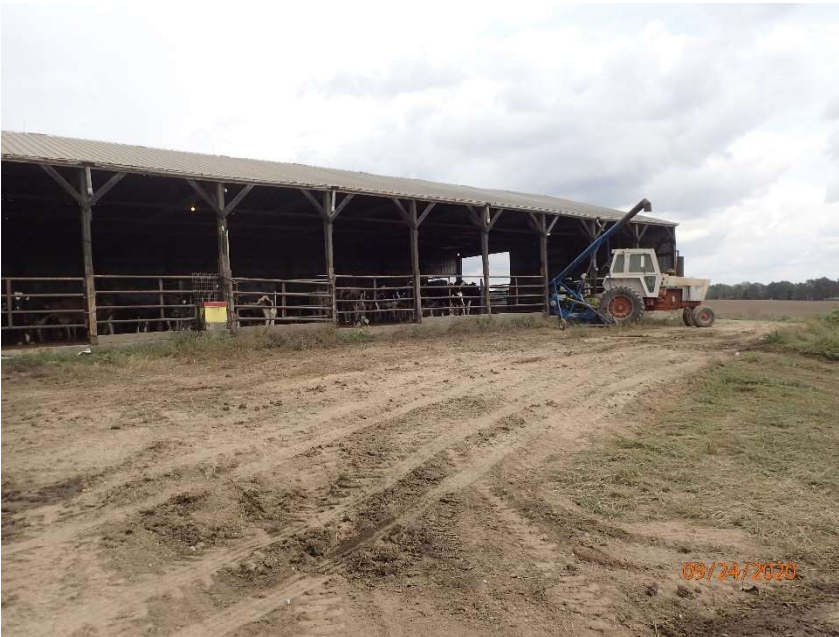
24: P9240024

Description: Looking northeast along south side of the Beef Barn.

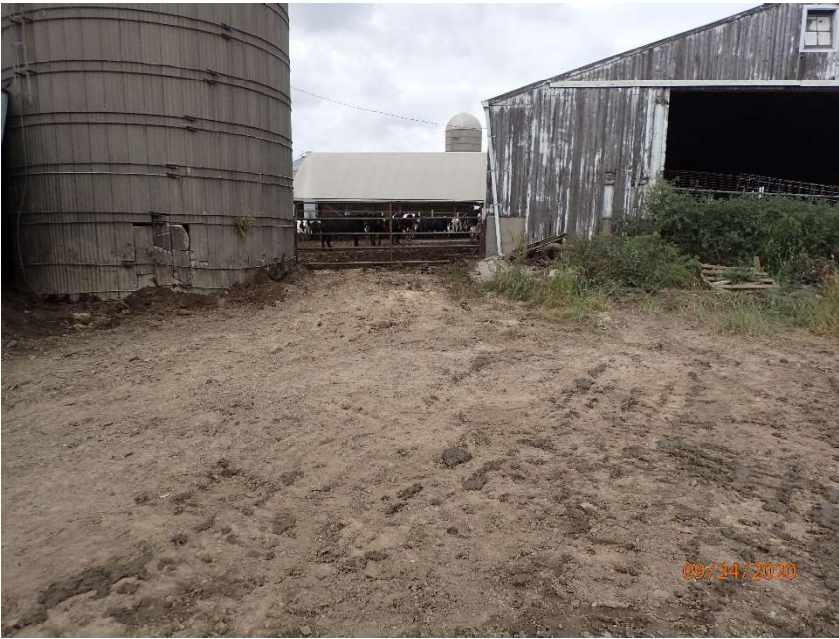
26: P9240026

Description: Looking west toward the Steer Lot.

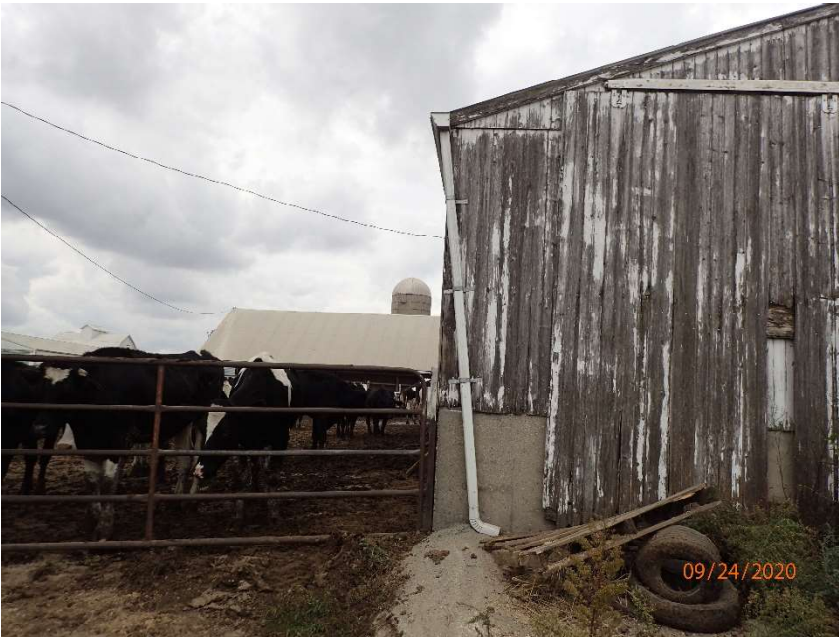
28: P9240028

Description: East side of the Steer Lot. Note gutter and downspout directing roof water away from the Steer Lot.

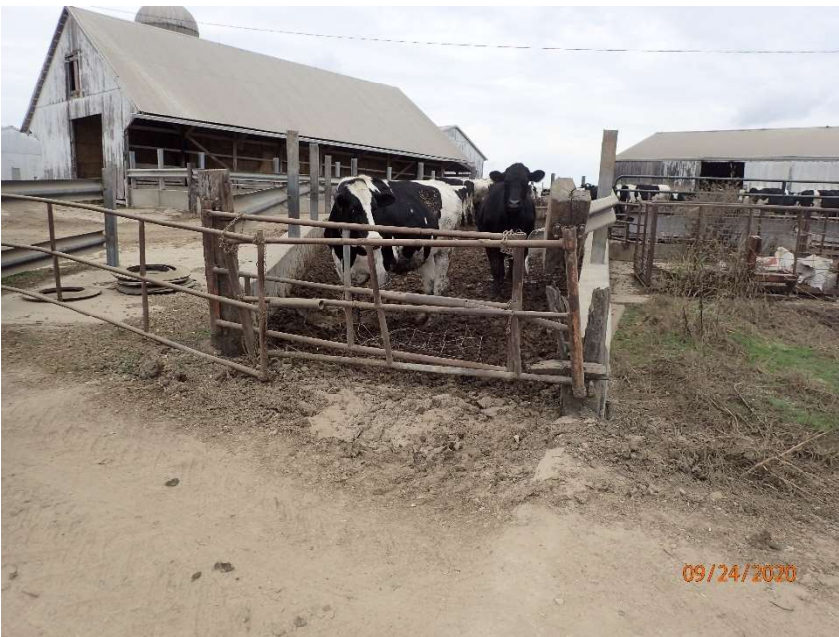
29: P9240029

Description: Curbed walkway between the Steer Lot and the Old Dairy Barn that conveys manure and process wastewater runoff to the pit under the Old Dairy Barn.

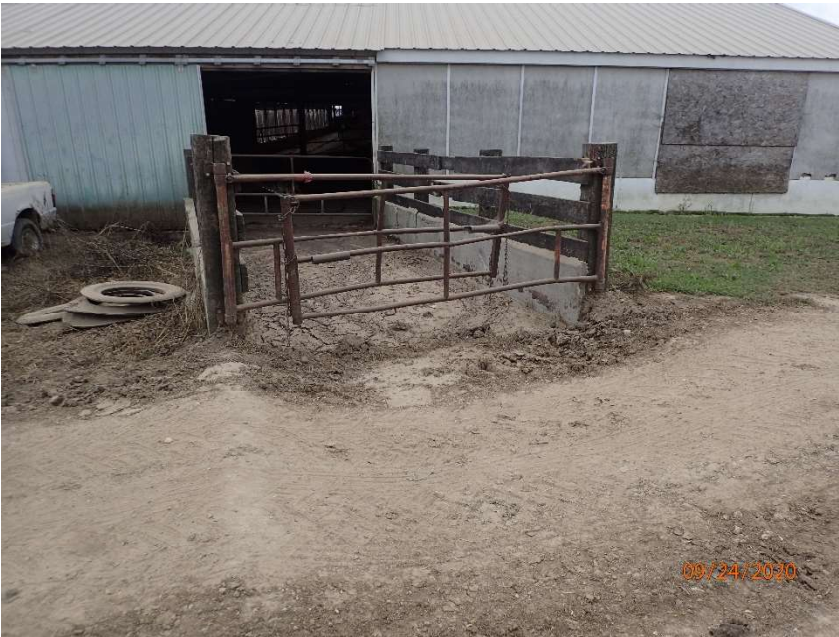
30: P9240030

Description: Curbed walkway between the Steer Lot and the Old Dairy Barn that conveys manure and process wastewater runoff to the pit under the Old Dairy Barn.

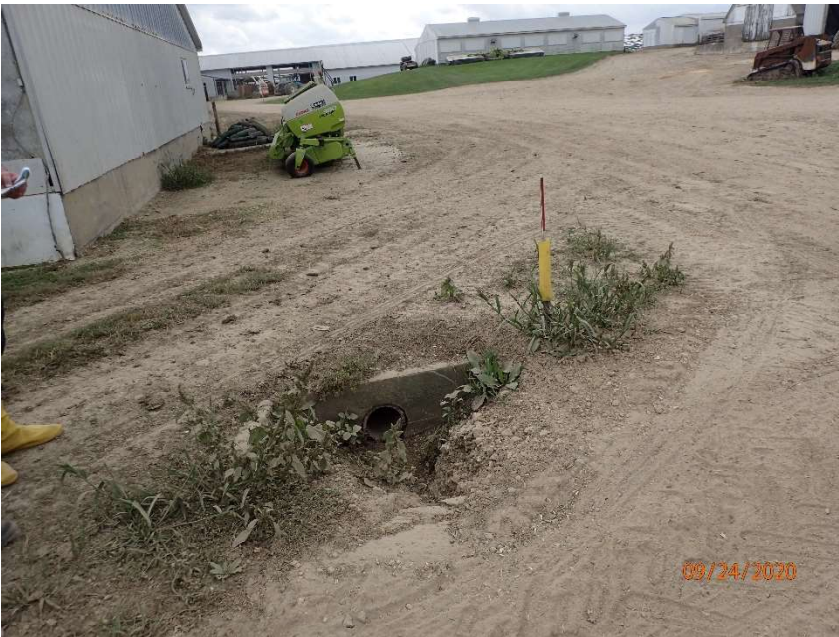
31: P9240031

Description: Stormwater inlet collects runoff from the roads and conveys it to the east side of the Facility.

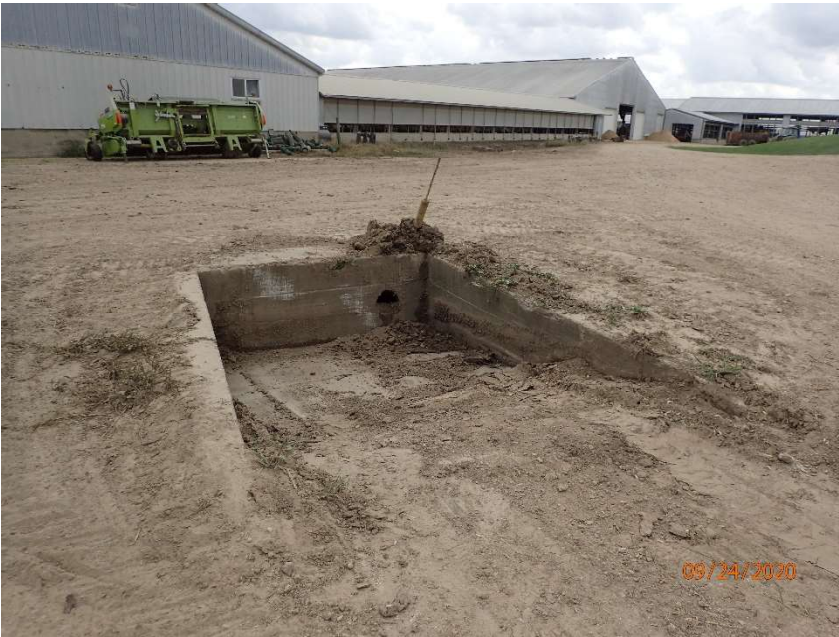
32: P9240032

Description: Stormwater inlet collects runoff from the roads and conveys it to the east side of the Facility. Note that this is a separate storm water drain than the one seen in Photo 31.

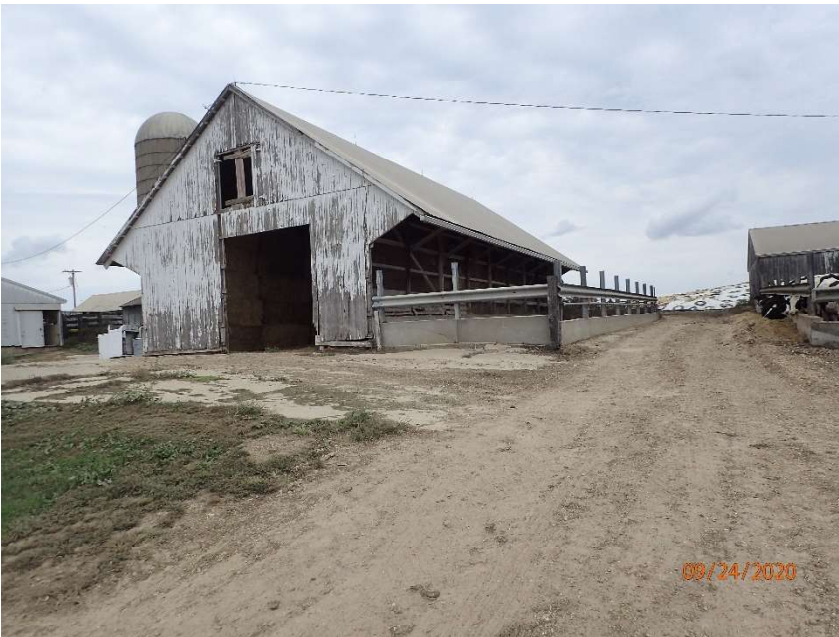
33: P9240033

Description: Looking North between the Hay Shed (left) and the Steer Lot (right). The west end of the North Silage Pad is seen in the distance.

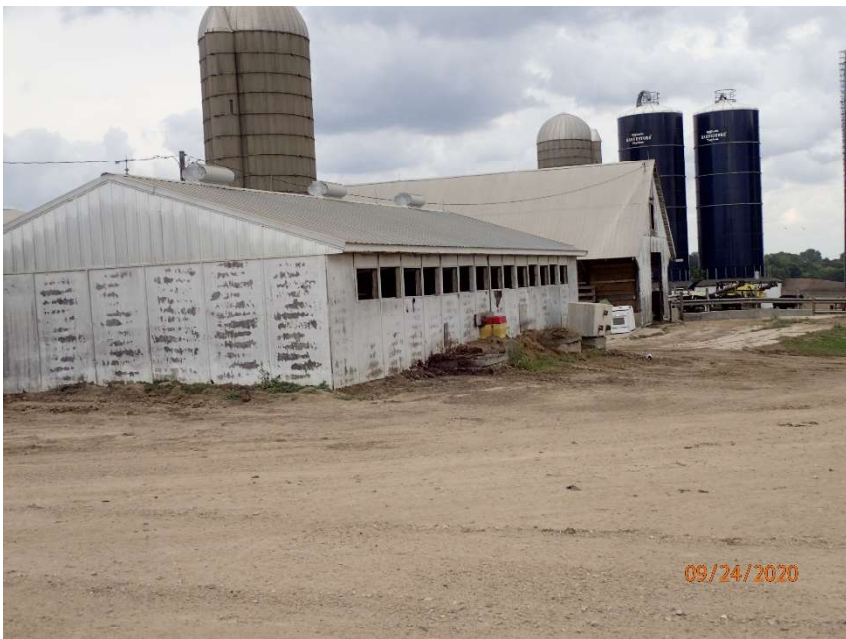
37: P9240037

Description: Looking east along the south side of Calf Barn 3.

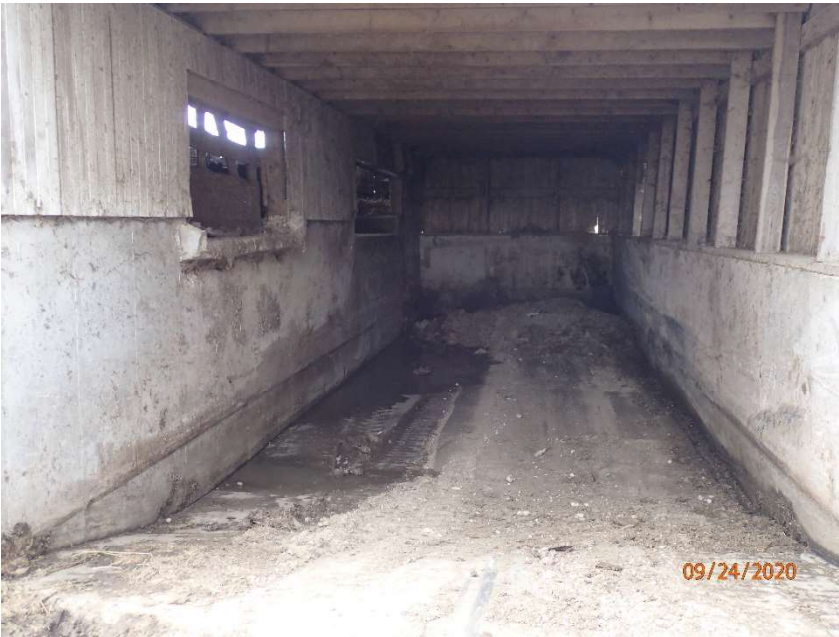
38: P9240038

Description: Manure loading area on the east side of Calf Barn 1. Manure and used bedding from the calf barn is stored here until it can be land applied.

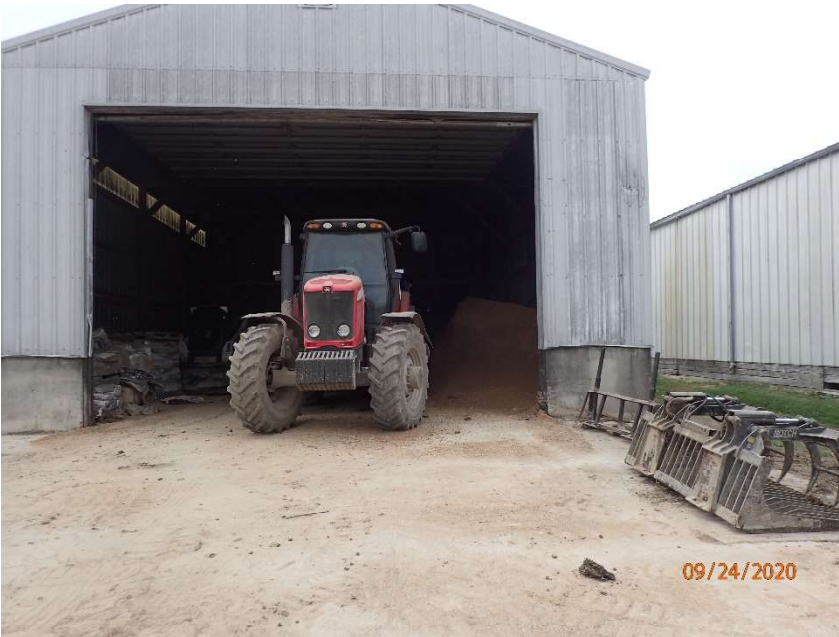
39: P9240039

Description: Looking west into the Commodities Building. Dry gluten and additional dry commodities were stored in here.

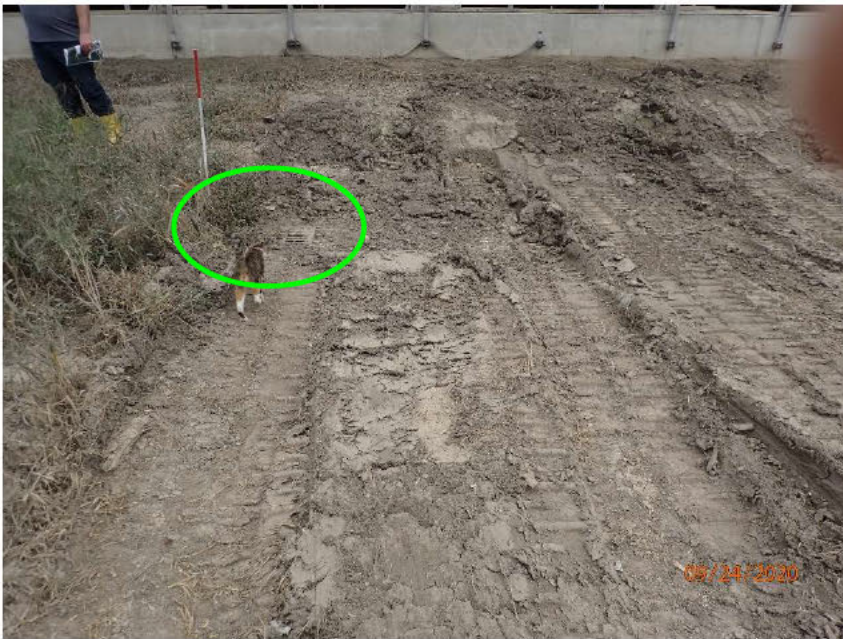
40: P9240040

Description: Surface inlet (denoted by the circle) west of the covered cattle walkway between the Old Dairy Barn and the Middle Barn. This inlet conveys flow to the east side of the Facility.

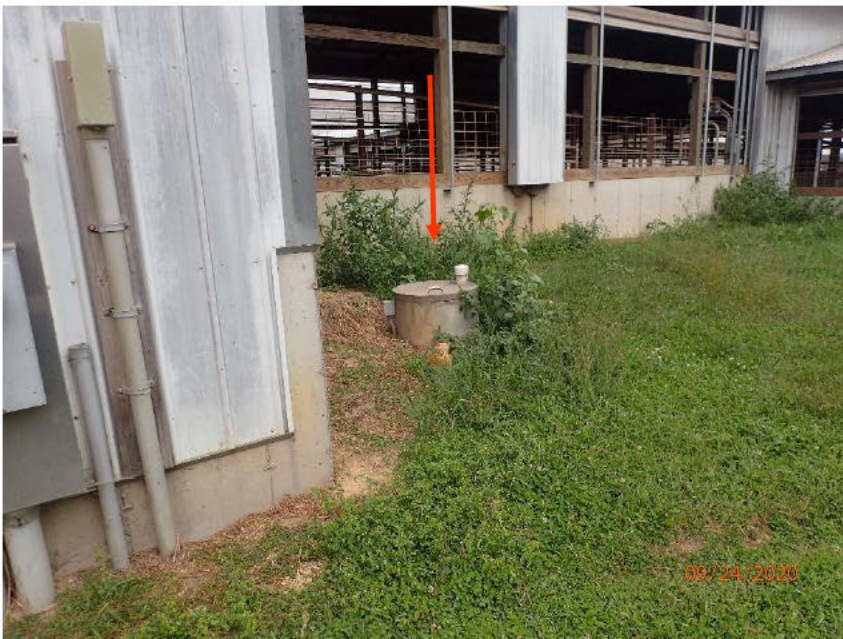
41: P9240041

Description: Area between the milking parlor the Big Barn. Note the access riser for the plate cooler water (arrow).

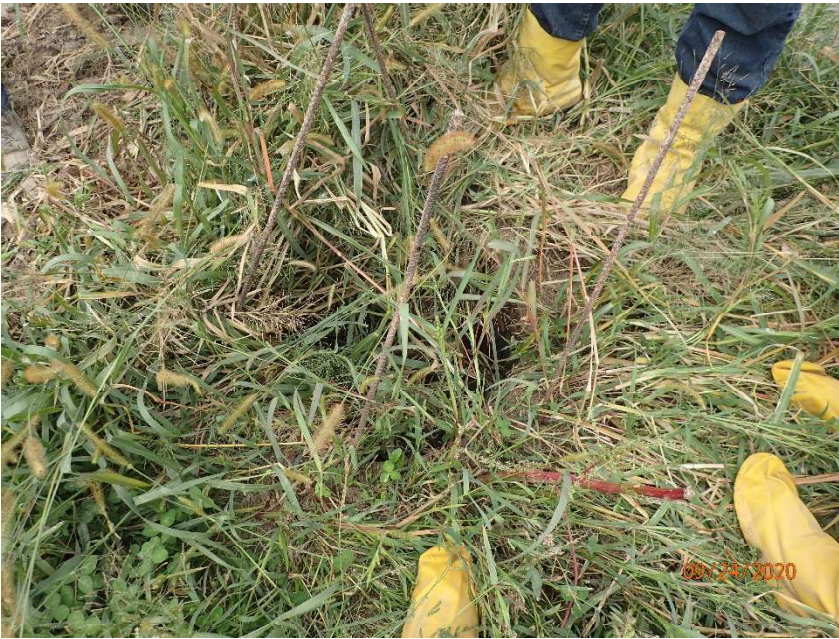
42: P9240042

Description: Surface inlet for drain tile that outlets storm water flow to the southeast of the facility.

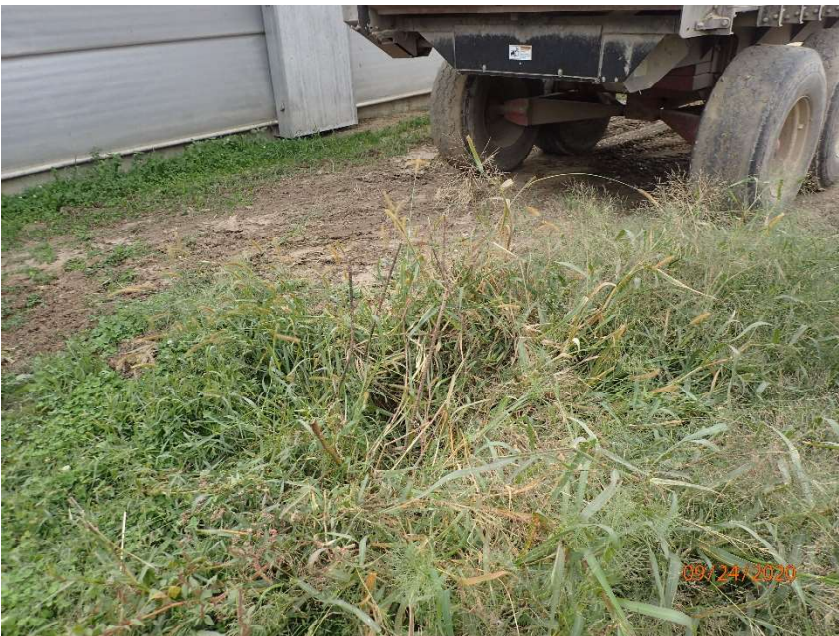
43: P9240043

Description: Surface inlet for drain tile that outlets storm water flow to the southeast of the facility. Same inlet as seen in Photo 42.

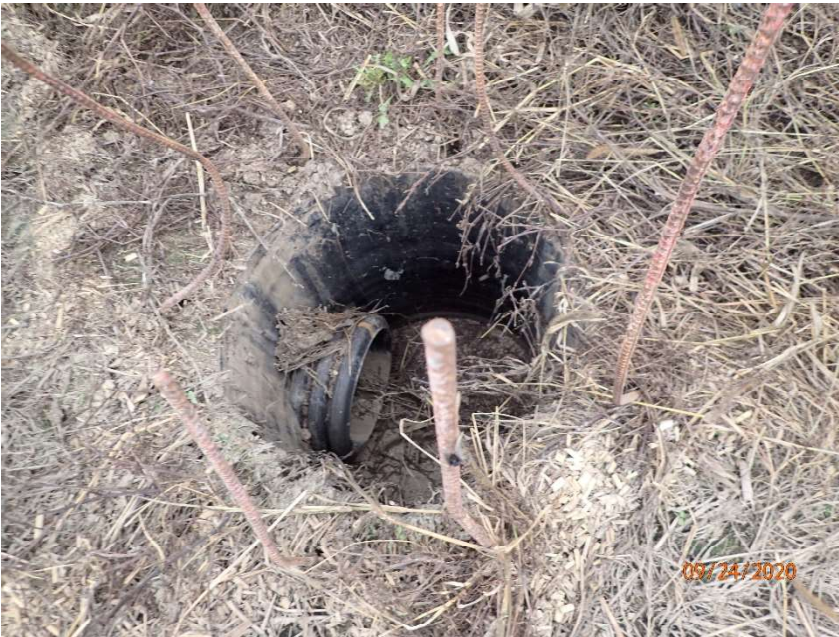
44: P9240044

Description: Additional surface inlet to drain tile on the north side of the Big Barn.

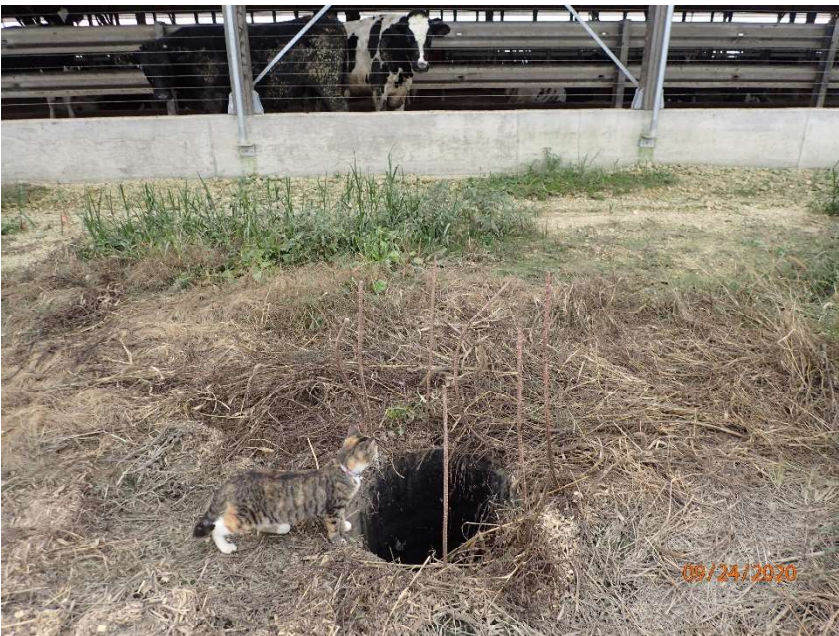
45: P9240045

Description: Additional surface inlet to drain tile on the north side of the Big Barn. Same inlet as seen in Photo 44.

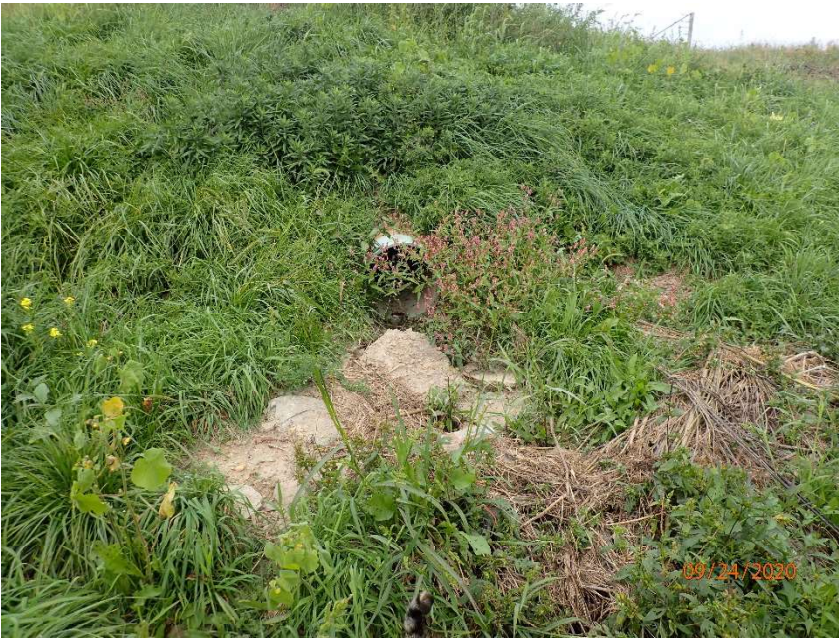
46: P9240046

The Inspectors walked back around the south side of the Big Barn and observed an outlet pipe on the hillslope southeast of the Big Barn (photo 46). The Operator stated that this pipe was the outlet for the inlets seen on the northside of the Big Barn as well as an inlet in the grassed area east of the Milking Parlor. The Inspectors walked to the grassed area east of the Milking Parlor and observed an outlet in the northwest corner of the grassed area (photo 47) which the Operator stated was from a drain on the northside of the Milking Parlor and an inlet in the southeast corner (photo 48) which the operator stated conveyed flow to the outlet seen southeast of the Big Barn (photo 46).

Description: Outlet of the surface inlets shown in Photos 42-45.

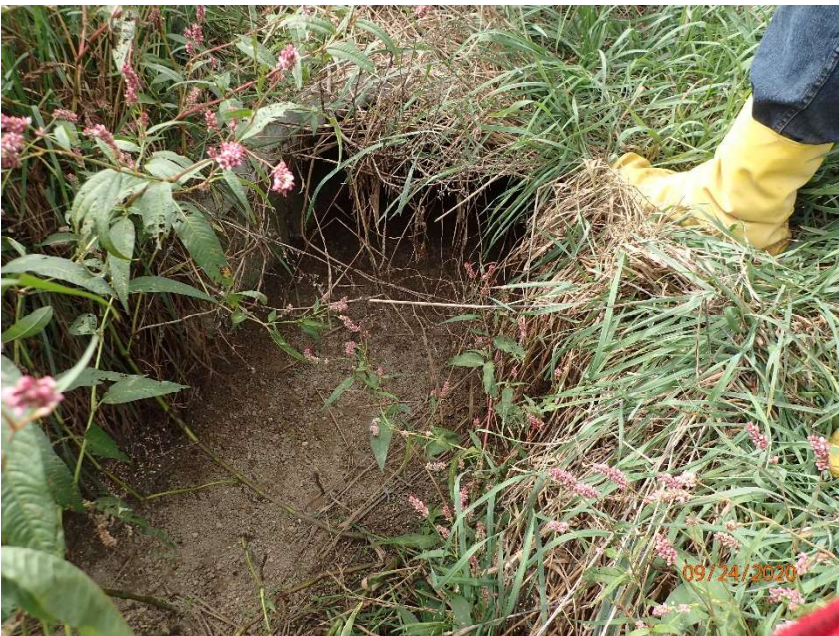
47: P9240047

Description: Outlet of surface drain north of the Milking Parlor to the grassed area east of the Milking Parlor.

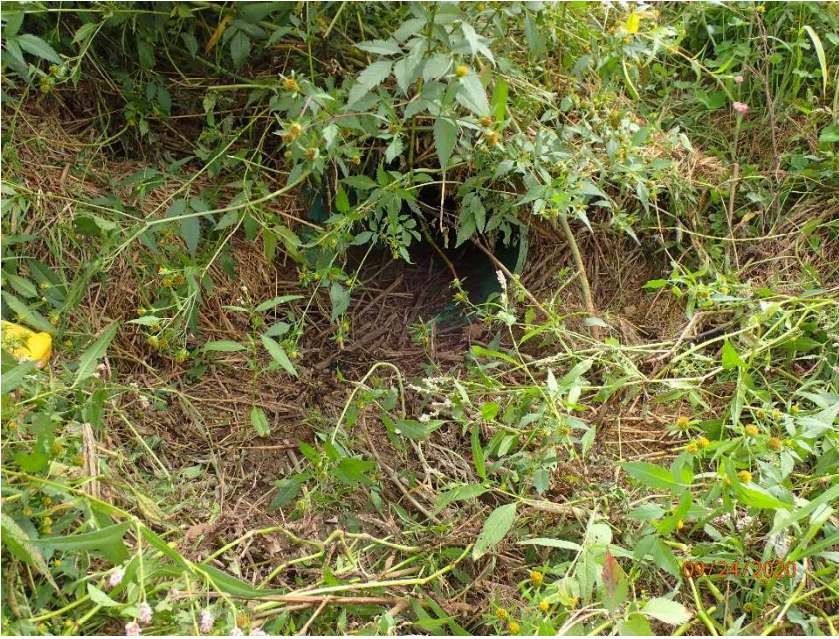
48: P9240048

Description: Inlet of surface drain in the southeast corner of the grassed area east of the Milking Parlor. The Operator stated that this inlet was connected to the outlet seen in Photo 46.
